USAAVLABS TECHNICAL REPORT 68-65

**ADVANCEMENT OF HIGH-TEMPERATURE TURBINE
TECHNOLOGY FOR SMALL GAS TURBINE ENGINES**

FLUID-COOLED AXIAL FLOW TURBINE

**CONTINENTAL AVIATION AND ENGINEERING CORPORATION
DETROIT, MICHIGAN**

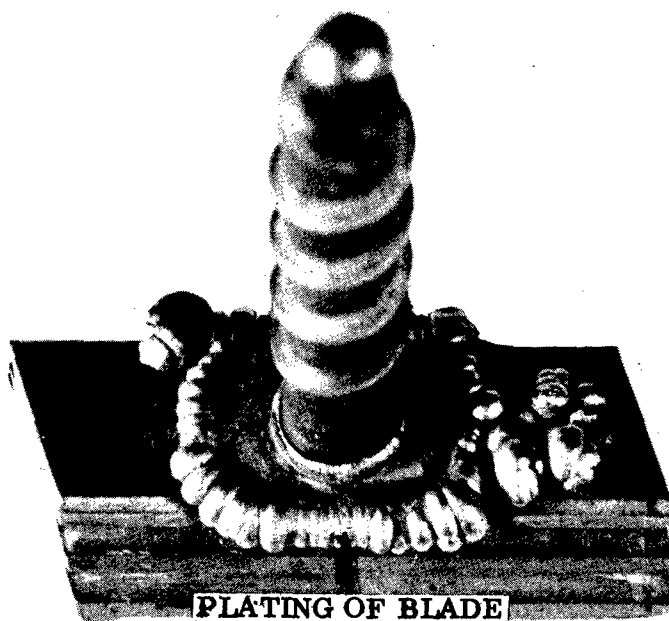
Figure 400. Nickel Plating of Blade.

The plating adherence was evaluated. For 1 hour, the plated blade was heated to 1300°F to check its resistance to spalling. A cross section of the blade was analyzed, Figure 401. The bond of the nickel plated to the Udimet 700 blade was satisfactory and showed no tendency to spall or separate. The blade was assembled into the turbine rotor and pressure checked with satisfactory results.

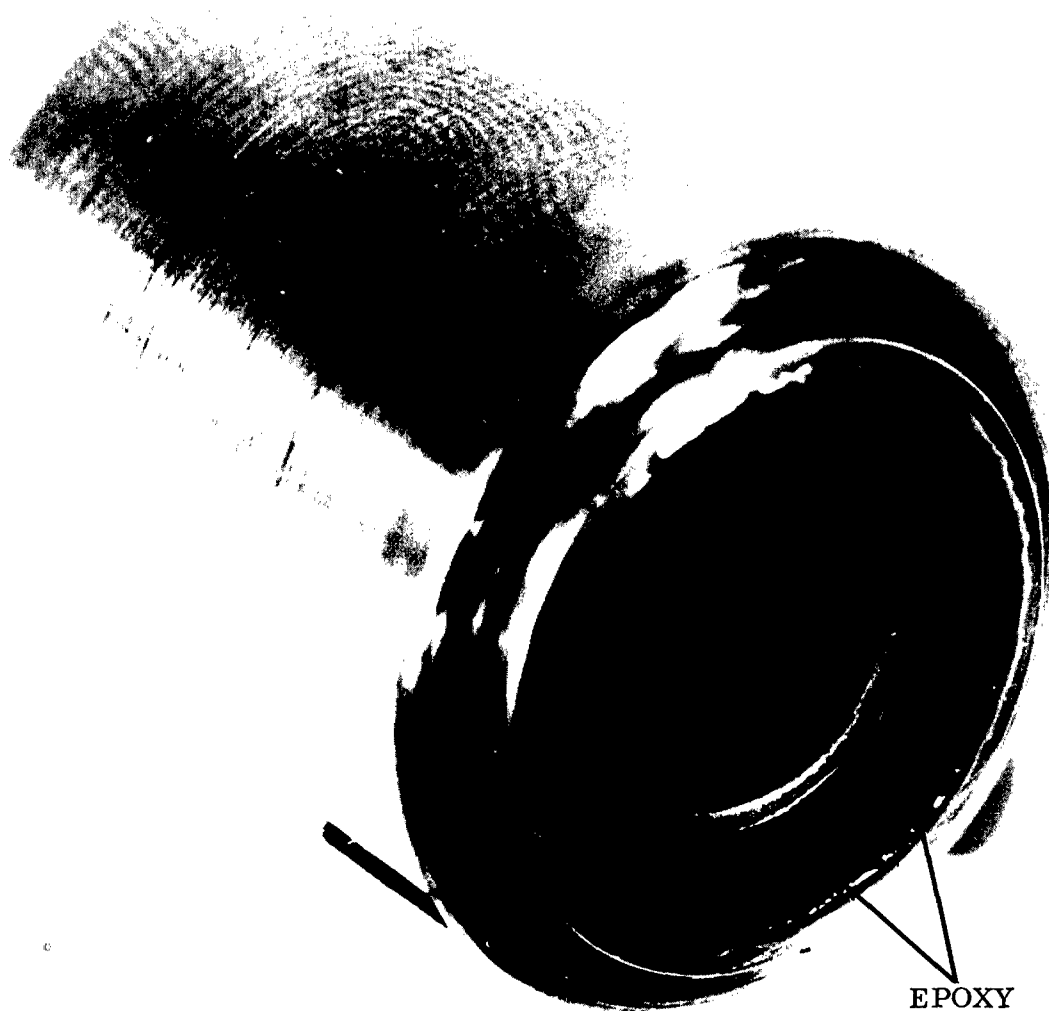
Figure 409. Fuel Face Seal.

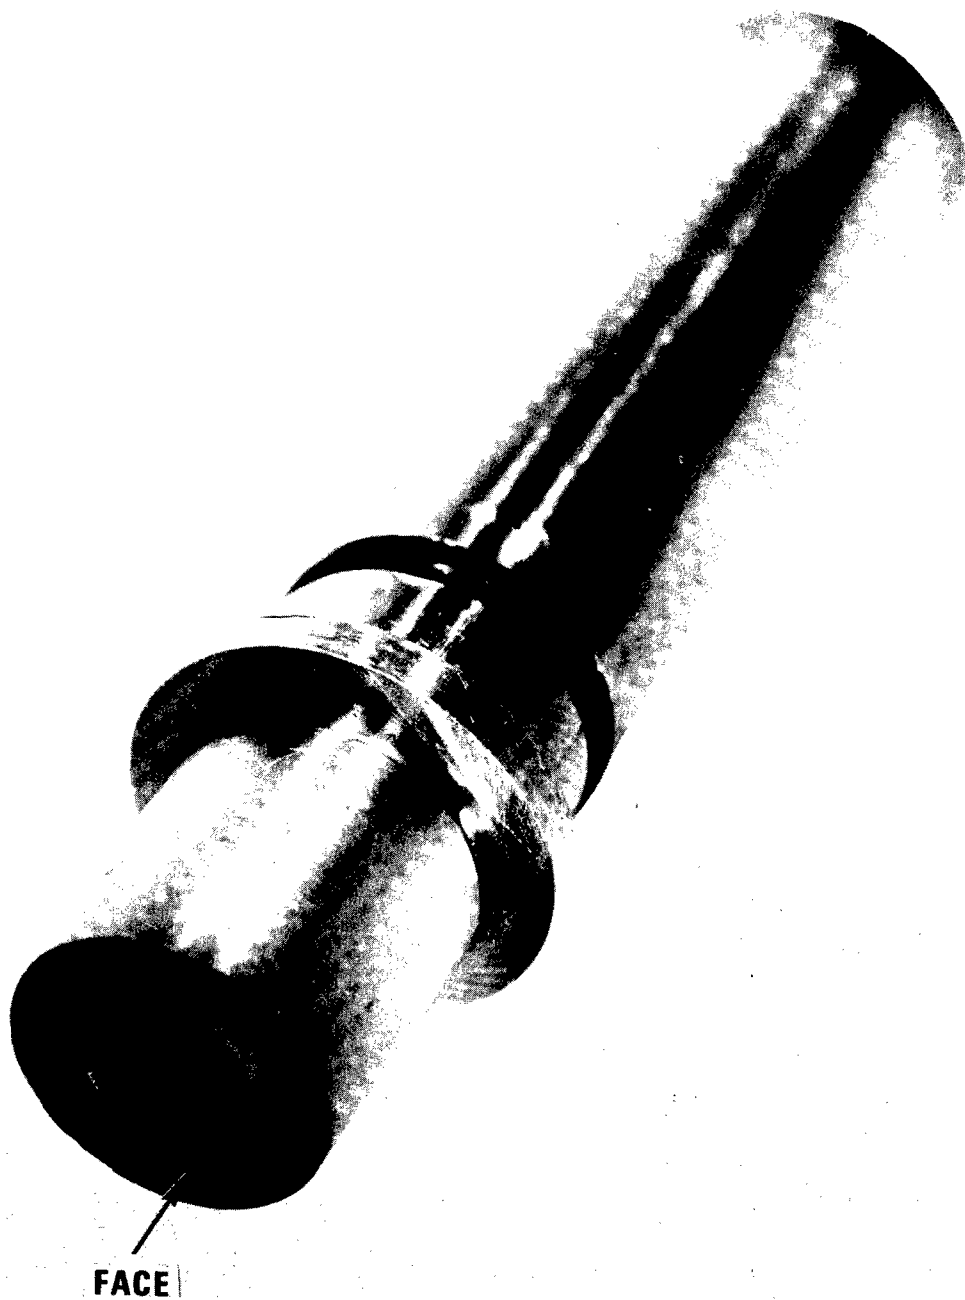
Figure 410. Fuel Wiper.

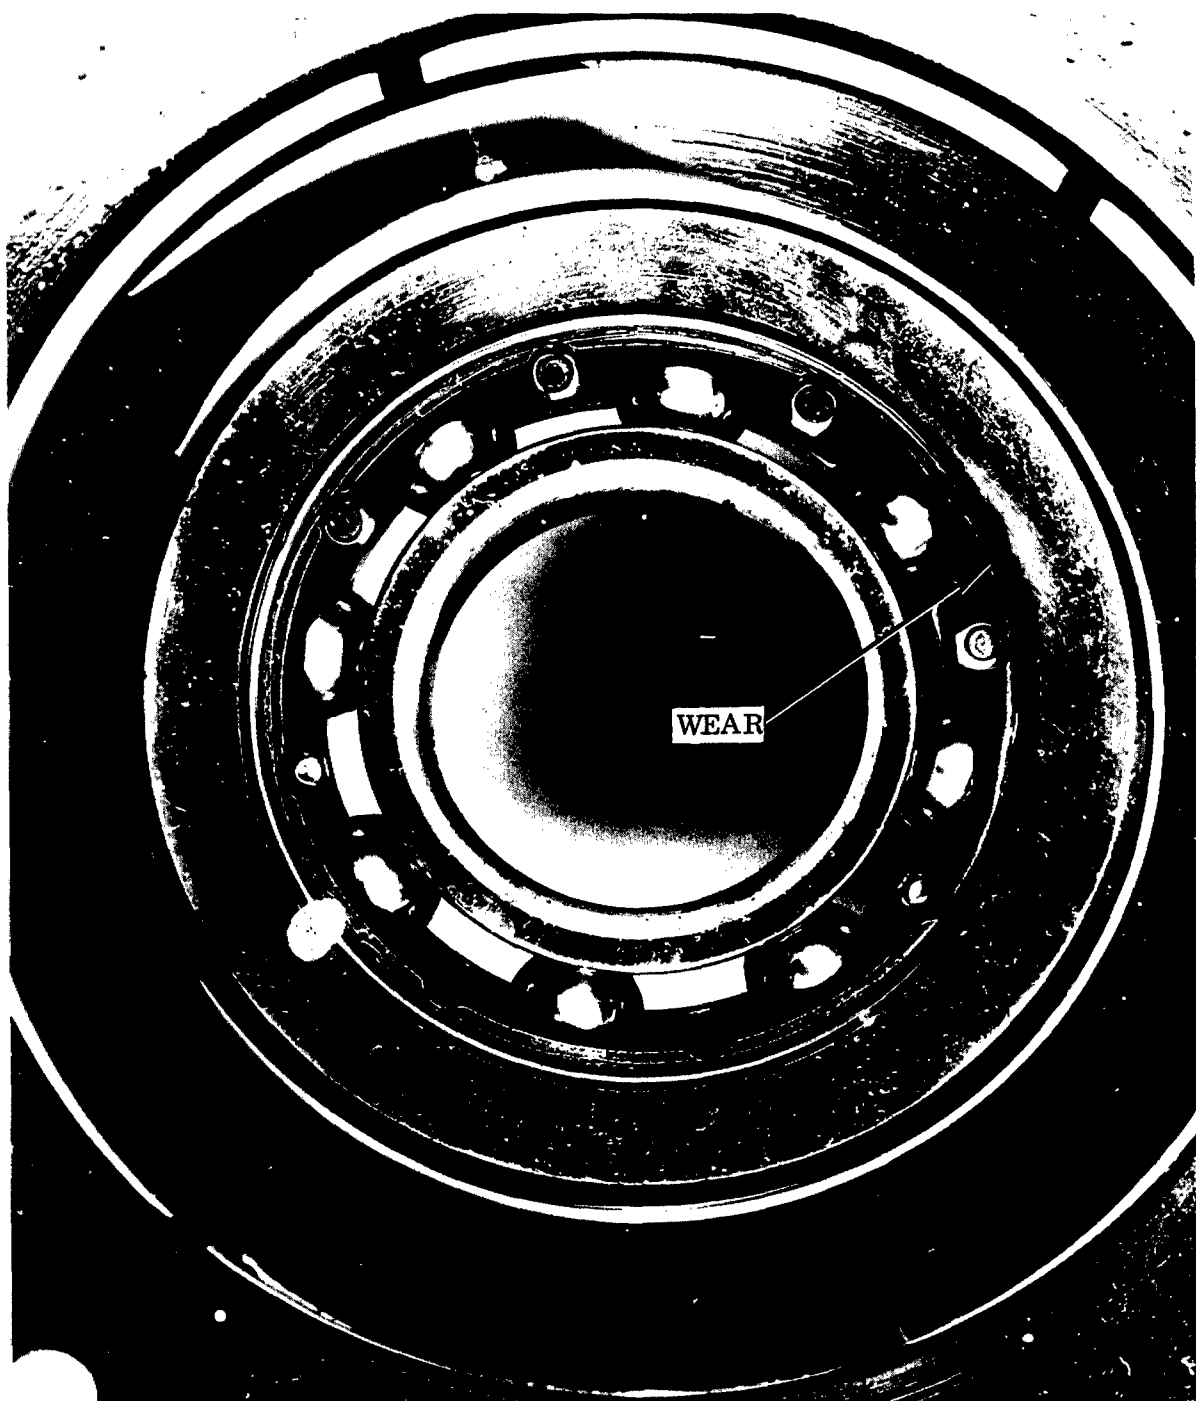
Figure 414. Forward Thrust Bearing.

The forward rig thrust bearing, Figure 414, displayed a cracked outer race cage. The bearing failure was surmised to occur when the rotor tip caps failed.

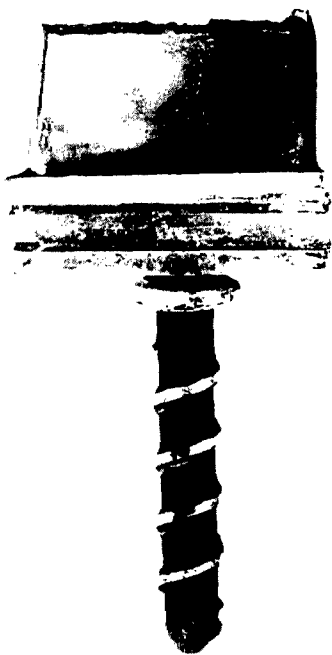
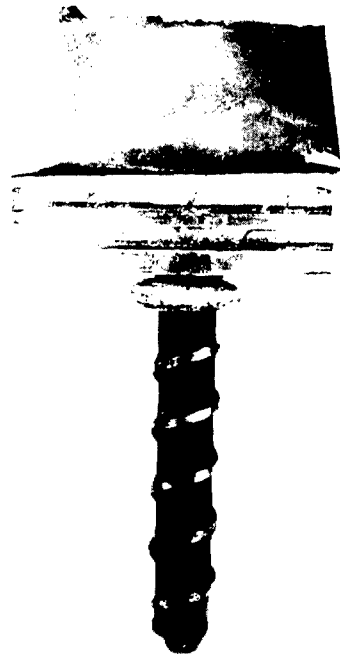
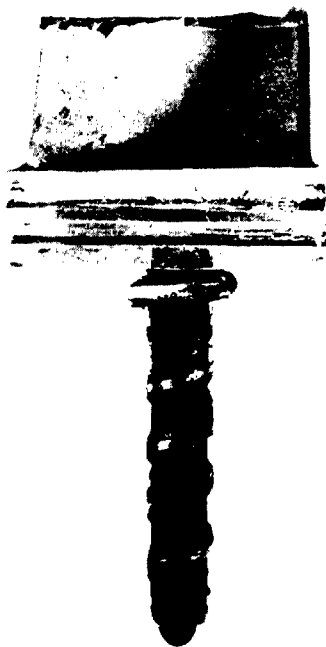
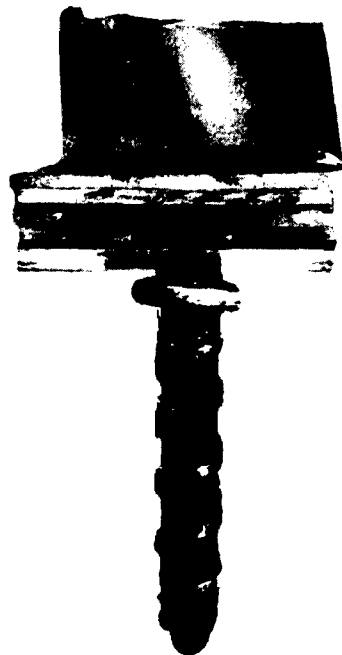
Figure 416. Fluid-Cooled Turbine Blade Nos. 25 and 37.

The blades were removed from the rotor, Figures 415 and 416. A reddish black deposit was found on all of the blade heat exchangers. The fuel seals were filled with a loose, flaky deposit. Samples of this deposit along with the test cell fuel (JP-4) were submitted to the Ethyl Corporation for analysis.

Longitudinal metallographic specimens were prepared from blades 37 and 51. It was found that both of the blades broke through the weld in the U-700 airfoil. The U-700 in the area of fracture was probably diluted with Inco 718 from the cap during electron beam (EB) welding. Both the concave and convex walls of blade 51 were "necked down", suggesting ultimate failure by hot tension, Figure 415. Cracks in the airfoil of blade 37 away from the weld were oxidized and also indicated hot tension, Figure 417. However, it exhibited no necking down or other distortion associated with the fracture of its convex wall.

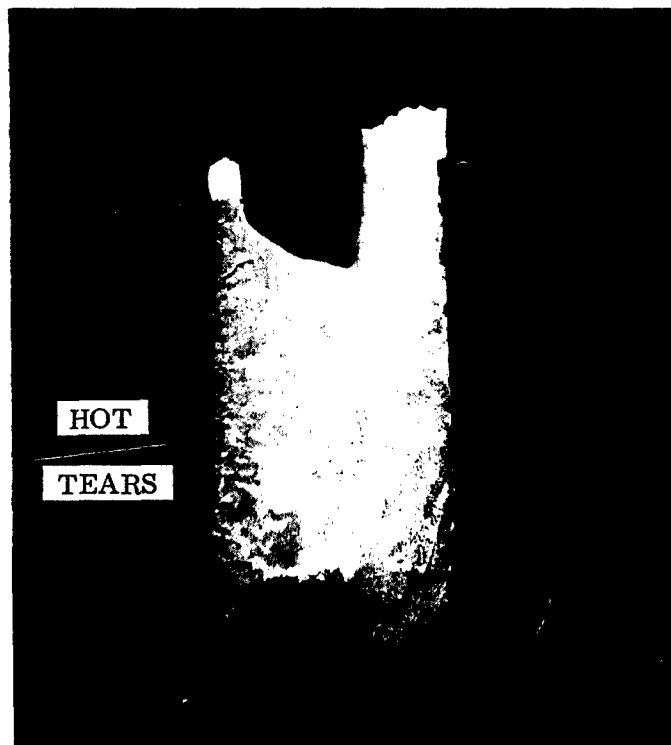
Figure 417. Blade 37 Fracture.

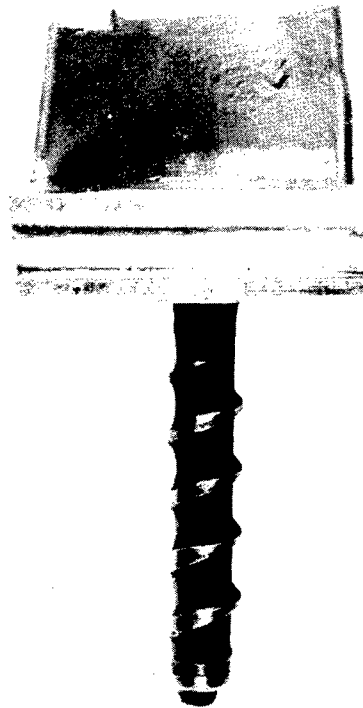
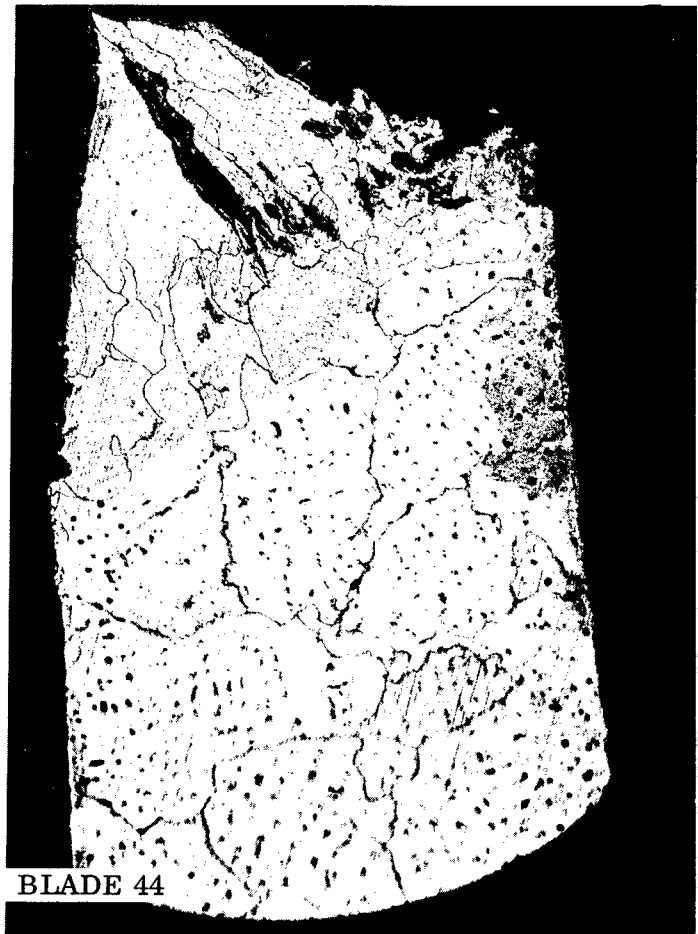
Figure 421. Blades 76 and 44 Microstructural at Weld.

1. Gamma prime was absent from the extreme 1/4 inch of the remainder of the broken airfoil, indicating that temperatures about 1900°F were reached in that area.
2. The grain structure of the airfoil had grown through the weld zone so that the only evidence remaining of the weld was a characteristic second phase, Figure 421.
3. Oxidation, alloy depletion, and metal flow near the fracture surface suggested that temperatures approaching the melting point (in excess of 2200°F) were reached in that area.

It was concluded that the blade airfoil reached metal temperatures in excess of 1900°F after loss of its coolant.

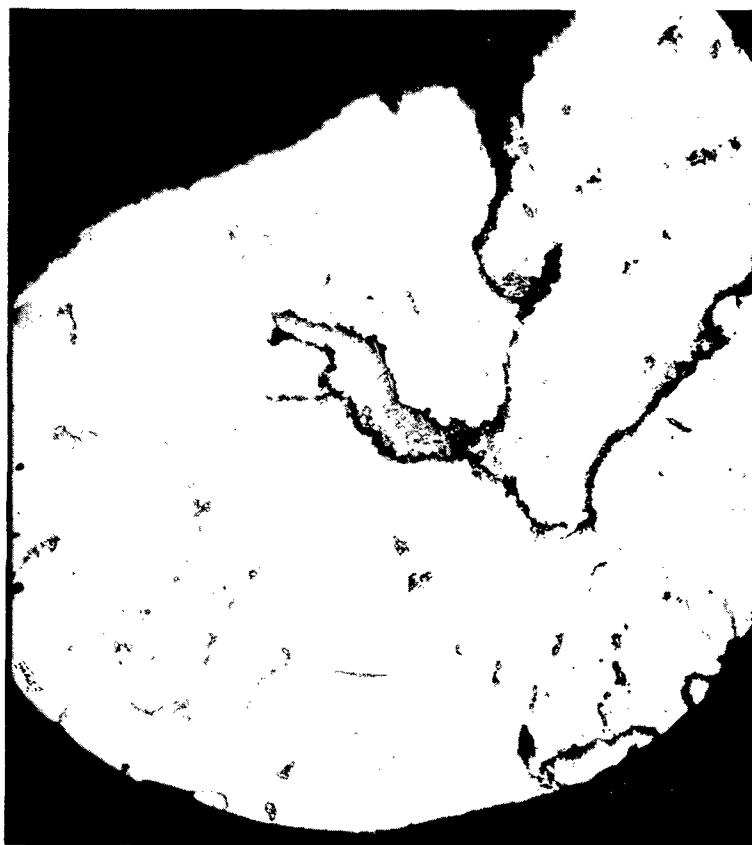
Magnification 500 X.

Figure 424. Blade 110 - Oxide Inclusion in Wall.

A metal discontinuity was visible to the unaided eye near the thinnest point in the airfoil wall of blade 110 about 1/8 inch above its platform. An intergranular film of oxide was found to be present; it extended entirely through the airfoil wall in several locations, Figure 424.

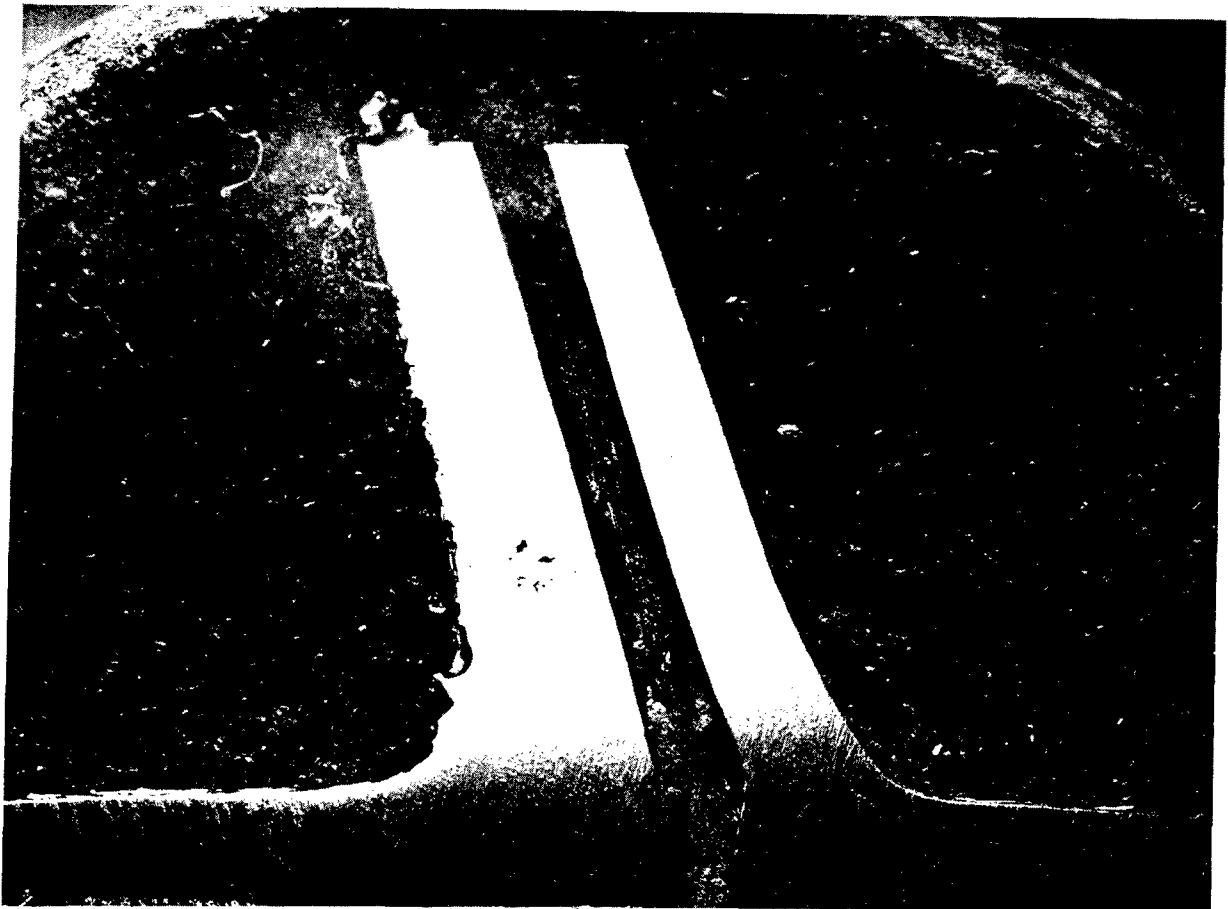
Sample castings were evaluated (see Appendix I). Metallurgical evaluation of accepted castings revealed sound metal throughout the airfoil, attachment area, and heat exchanger (free from porosity, shrink, and gas holes). However, radiographic inspection revealed internal oxide inclusions in some of the castings. Verification was made microscopically, Figure 457, and the parts were rejected.

Figure 457. Photograph of Blade Microscopic Showing Area of Oxide Inclusions and Shrinkage.

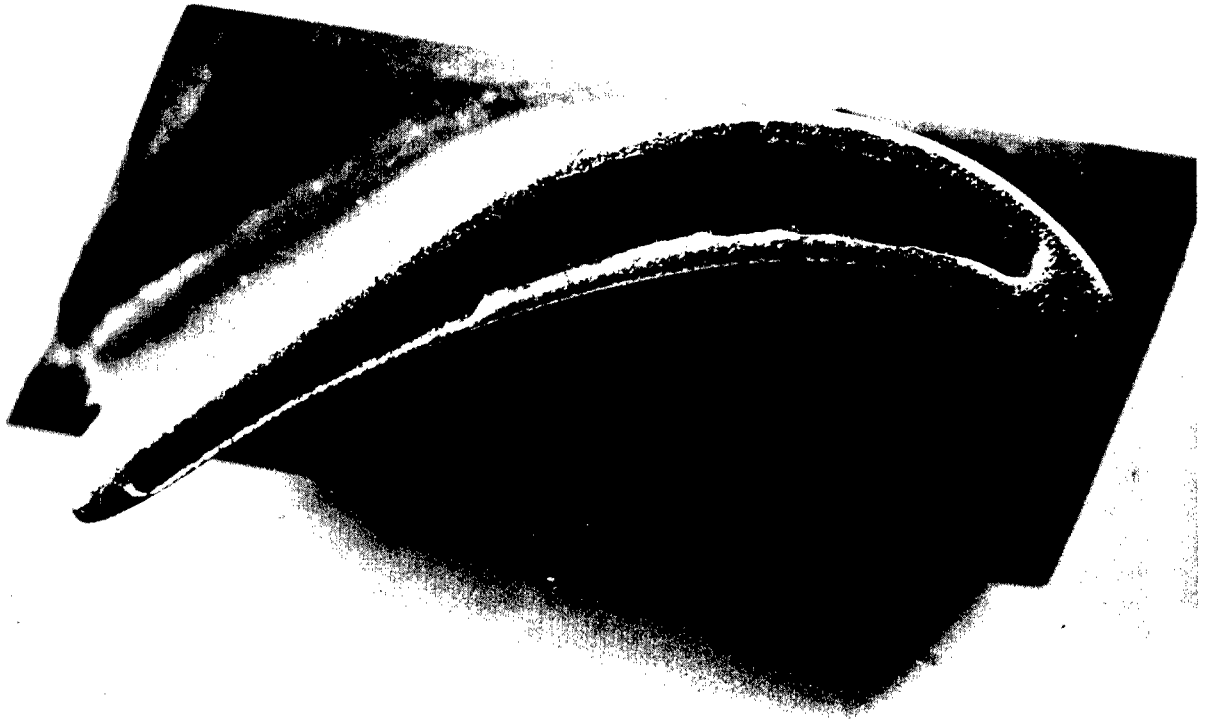
The tip station was accessible, and the wall thickness was checked 100 percent. A typical undersize tip thickness is shown in Figure 458 and was caused by a core mismatch. The midspan thickness could only be spot checked, because spot checking had to be done by destructive tests. A tip minimum thickness check was made and certified by the casting vendor on all blade castings.

Figure 458. Blade Showing Thin Wall at Trailing Edge Caused by Core Mismatch.

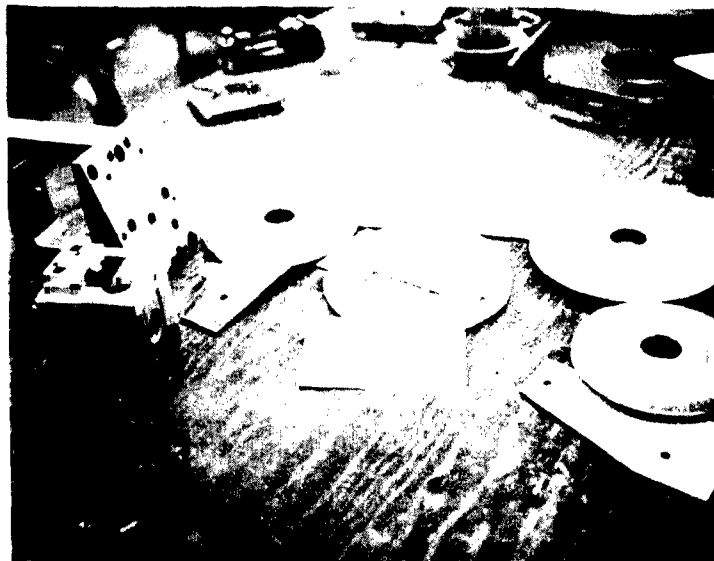
The tooling and templates used in the machining operations of the blade are shown in Figures 460 and 461. A shuttle fixture was used for positioning the cast blade in the holding fixtures prior to imbedding with a soft metal matrix, Figure 461.

Figure 461. Blade - Grinding Wheels and Dressing Templates.
